Manhole Inspection Summary

Manhole # S21U__007MH

Location Address: **2101 washington bd**

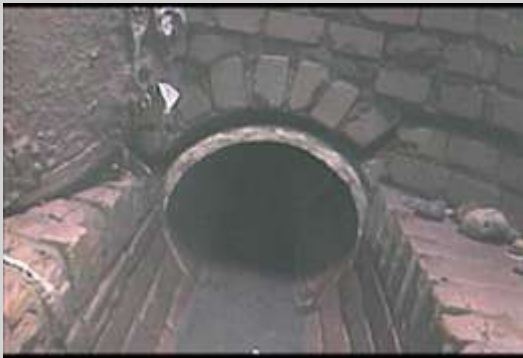
12 O'Clock Outflow

15 in. Circular Gravity Sewer
Pipe Out @ 12 O'Clock

Pipe Height: **15.6** (in.) Rod and Bar (Angled)
Pipe Material: **Clay** ☐ Pipe Lined
Invert Depth: **8.78** (ft.) Flow Characteristics: **Slow**
Deposits: ☒ None ☐ Mud ☐ Sludge ☐ Debris ☐ Grease
Silt Depth: **0** (in.) Deposits Extent:
Infiltration: **None** Pipe Seal Cond: **Sound**

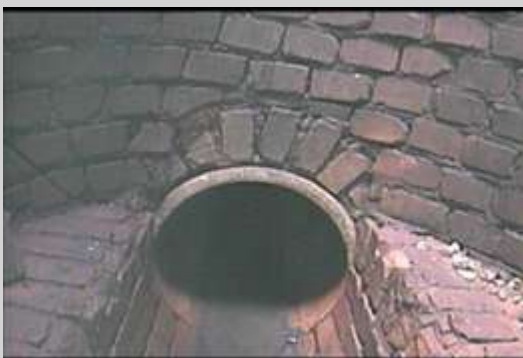
6 O'Clock Inflow

15 in. Circular Gravity Sewer
Pipe In @ 6 O'Clock

Pipe Height: **15.6** (in.) Rod and Bar (Angled)
Pipe Material: **Clay** ☐ Pipe Lined
Invert Depth: **8.69** (ft.) Flow Characteristics: **Slow**
Deposits: ☒ None ☐ Mud ☐ Sludge ☐ Debris ☐ Grease
Silt Depth: **0** (in.) Deposits Extent:
Infiltration: **None** Pipe Seal Cond: **Sound**
